SLUDGE SEDIMENT BASIN RETROFIT

Project Scope Highlights

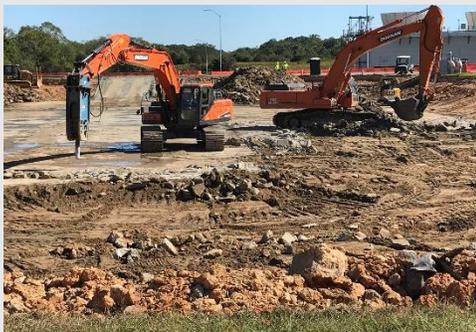
Concrete Liner Demolition

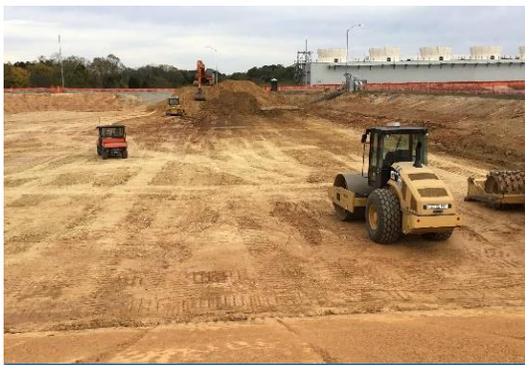
Subgrade Preparation

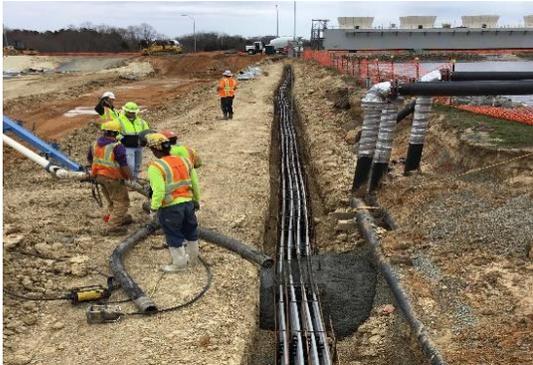
Electrical Duct Bank Install

- During the electrical system replacement, an existing duct bank was found in an unexpected location. This caused the duct bank to be relocated earlier in the project than originally anticipated, which impacted the liner system installation phasing. Trans Ash worked jointly with the design engineer and owner to implement the best solution to this problem.

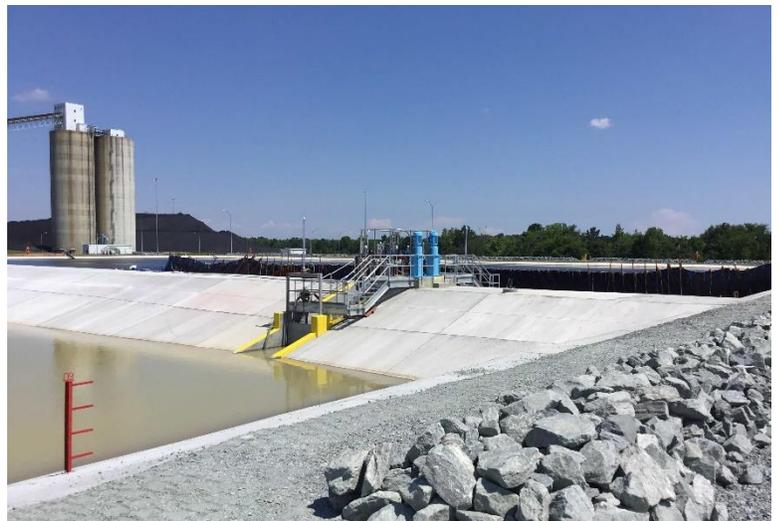
Completed Pump Station

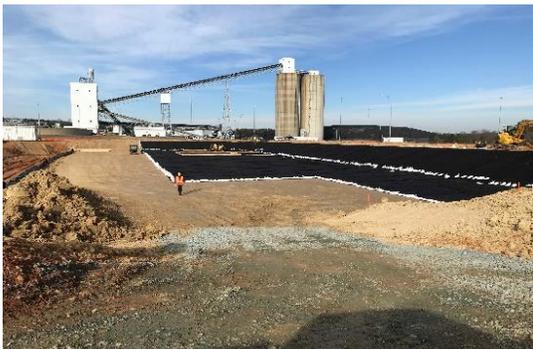
Geosynthetic Liner System Install

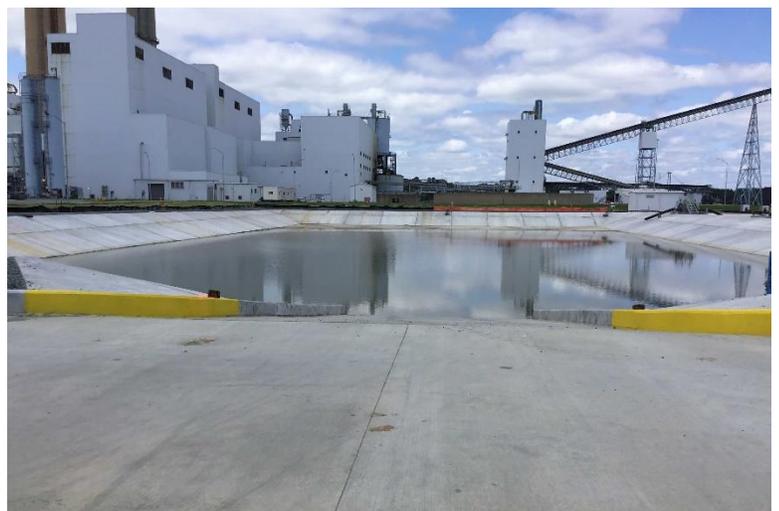
Completed Sludge Sediment Basin

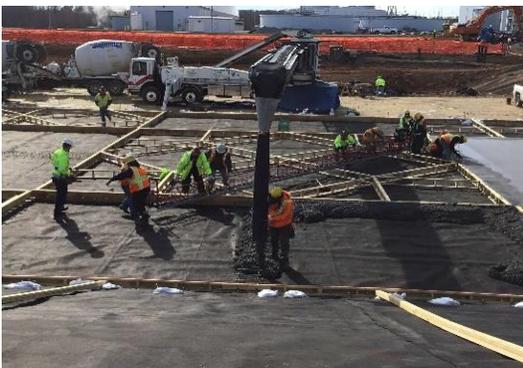
Concrete Liner Install
