CCR BASIN CLOSURES

Process Water Basins

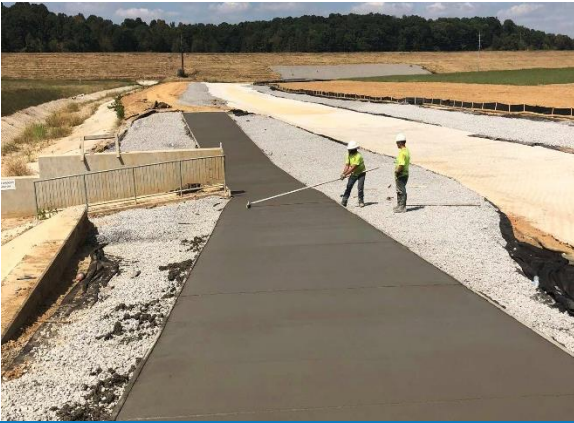
Spillway Concrete Installation

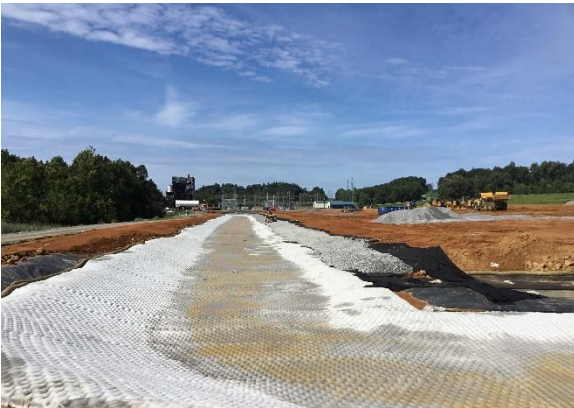
Fabric-Form Ditch Installation

- Cap in place of two fly ash/bottom ash basins
- Clean closure of the SO₂ basin
- Excavate, dewater, load, haul and place approximately 416,000 CY of CCR material
- Install 72 Acres of geosynthetic liner
- Development and operation of offsite borrow pit for 229,000 CY of cover soil
- Install 116,500 SF of fabric-form ditch
- Install two concrete lined process water basins, including 1,000 LF of concrete lined pipe
- Dike stabilization with rigid inclusions and stone buttressing

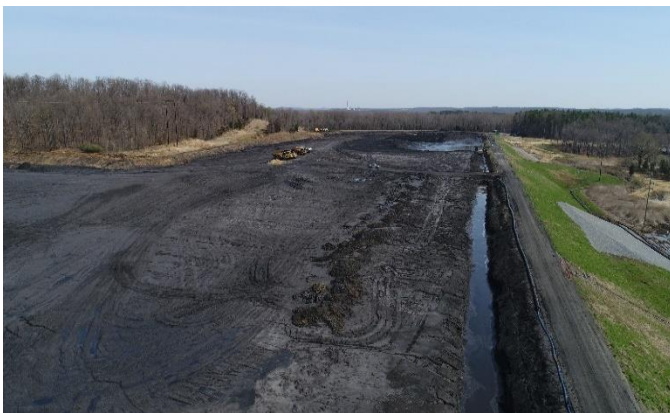
Original Basin Conditions

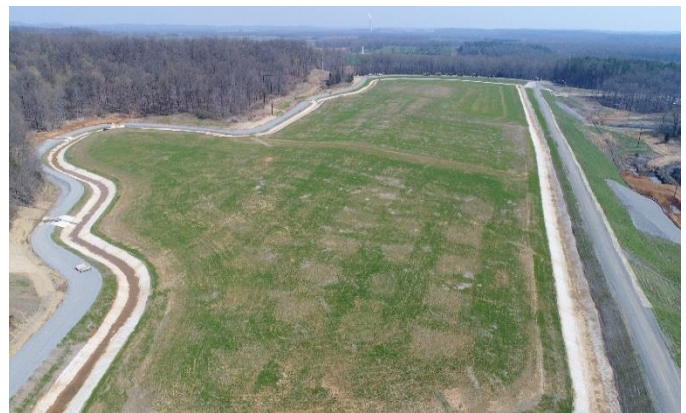
Final Basin Conditions
