TEMPORARY LINED BASIN

Project Overview

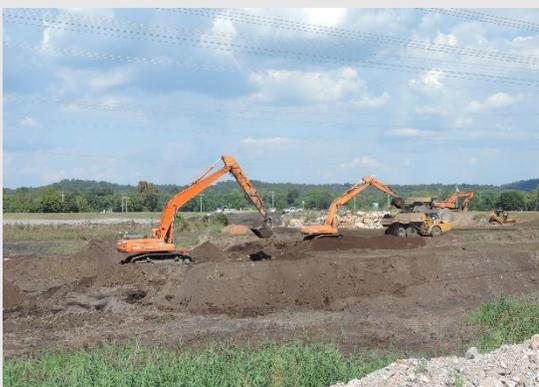
Initial Excavation

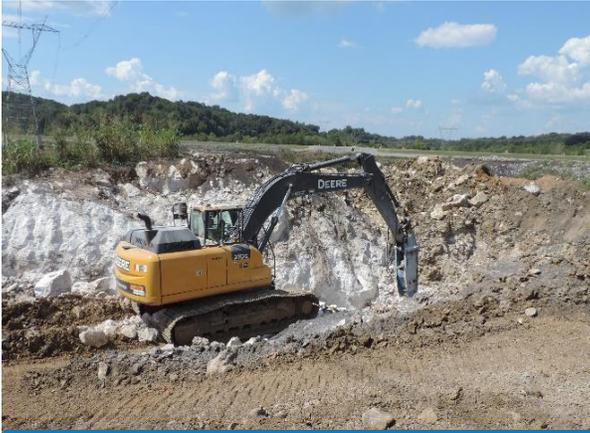
Rock Removal

- During excavation, an unexpected section of rock was encountered. Trans Ash utilized an excavator with a hammer attachment to demolish the rock, while working concurrently on other project activities. By adapting to the changing conditions Trans Ash was able to avoid delays and maintain the construction schedule.

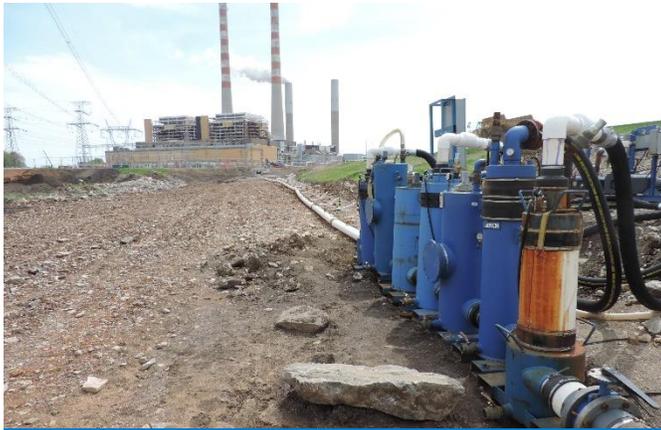
Well Point Dewatering System

- In order to deem the work area safe, the phreatic water level was monitored daily and had to remain below a specified elevation. Despite considerable effort, the basin, subgrade material did not respond to conventional dewatering methods. As a result, Trans Ash employed a water management subcontractor to install hundreds of well points and remove the sub surface water. The process was successful, and Trans Ash was able to maintain the phreatic water level below the specified elevation.

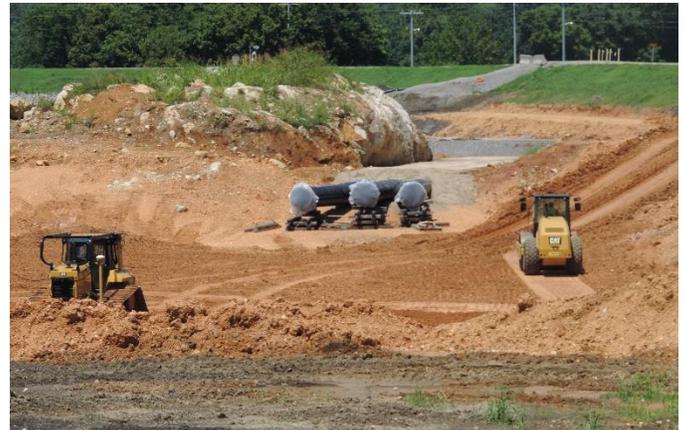
Subgrade Preparation

- While excavating to reach subgrade, many areas were still too wet. Trans Ash focused its resources on digging sumps and over excavating. The sumps were able to remove the water long enough to allow stabilization of the undercut with stone and geogrid.

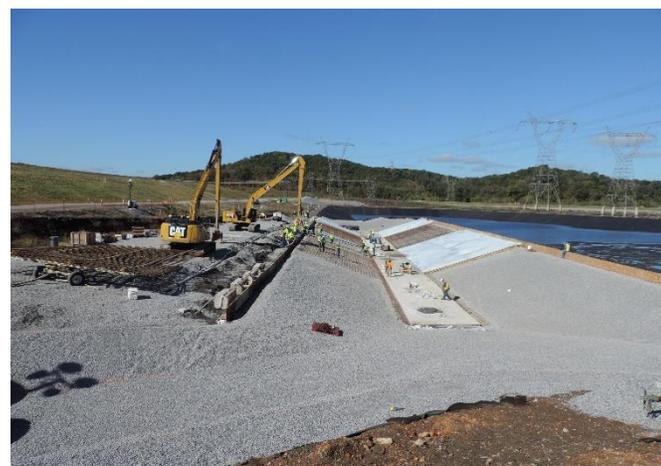
Prep for Concrete Pour

- The biggest challenge of the project was placing a subgrade of #57 stone, to grade, on the slopes of the forebay below the concrete. Trans employed an additional work force and multiple surveyors to continually check grade and adjustment, as necessary, to maintain grade until the concrete was ready to be poured.

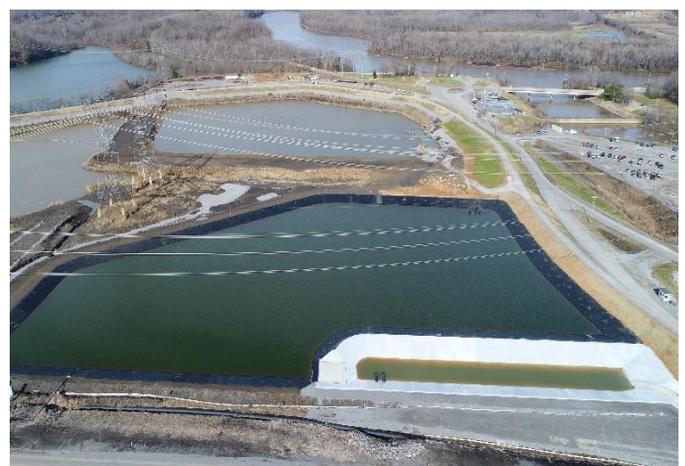
Completed Basin
