## CCR LANDFILL and BASIN CLOSURE

### Project Overview

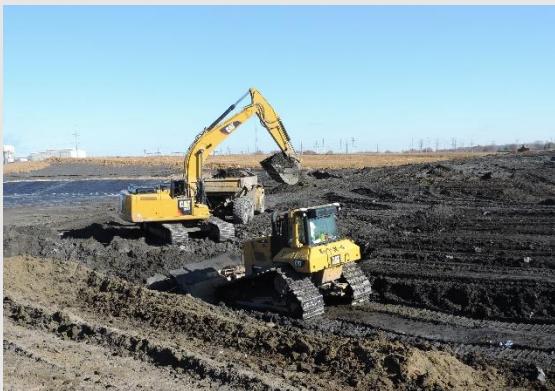
Basin Excavation

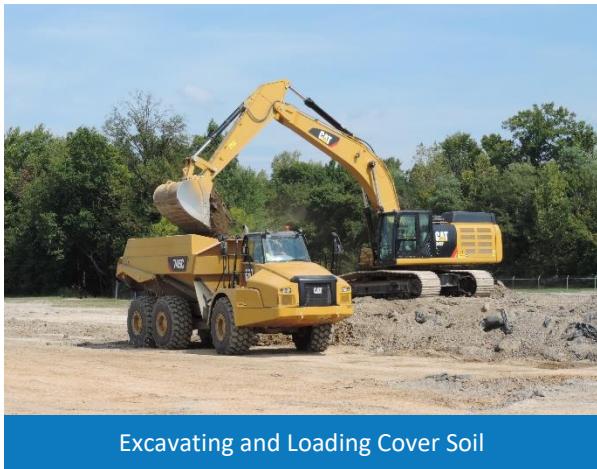
Excavating and Loading Cover Soil

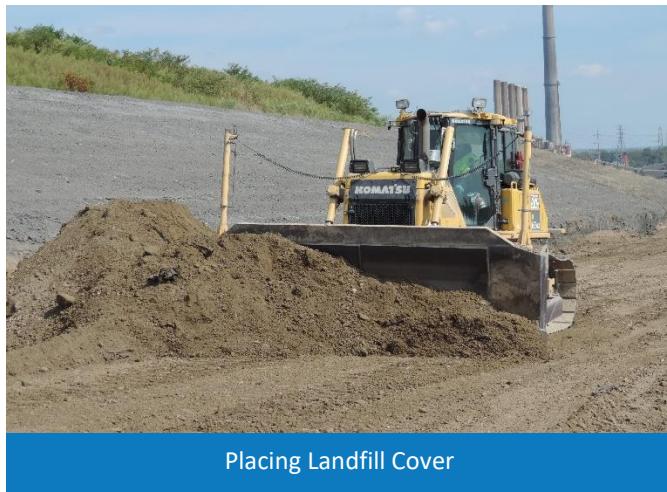
Placing Landfill Cover

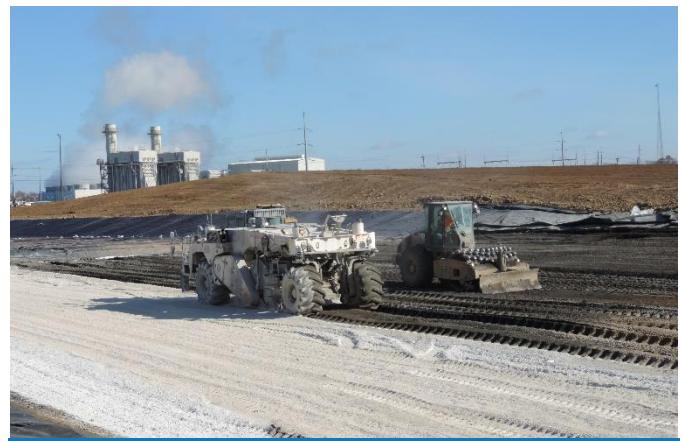
Basin Bottom Stabilization

- The storm water basin required a regulatory agency observed proof roll and compaction testing. Trans Ash used its vast CCR handling experience to dry the majority of the material through mixing and spreading in thin lifts. However, a small section of the basin bottom resisted traditional drying methods. Lime kiln dust was applied to ensure the material was dried and compacted to the required specification.
